# Inspection Report

*Property Address:*  
*27100 North 130th Lane, Peoria Arizona 85382*  
*Inspection Date:*  
*November 22, 2006*

**DIAMOND HOME INSPECTIONS LLC**  
Email: [michael@diamondhomeinspections.com](mailto:michael@diamondhomeinspections.com)  
Phone: (602) 499-6995  
Fax: (623) 594-7559

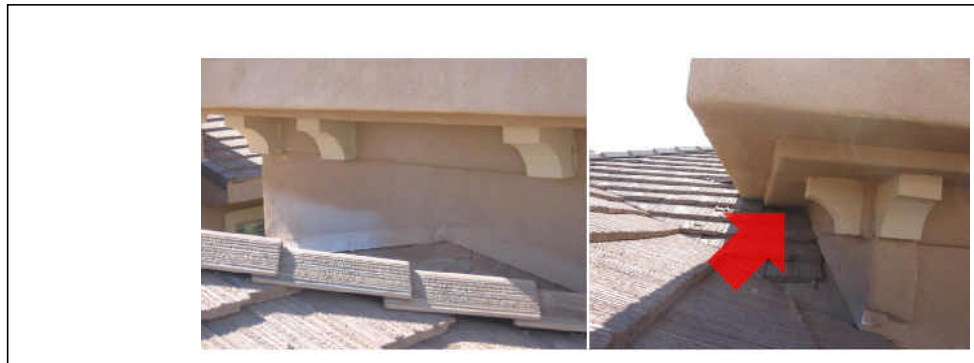
#### 307 STUCCO SIDING:

- a. [CR] The stucco siding was not completed at the entry left side overhang of the building. These conditions are conducive to moisture intrusion/deterioration. We recommend correcting the condition(s) noted.
- b. [CR] The stucco siding finish (paint) was missing at the entry tower. We recommend correcting the condition(s) noted.

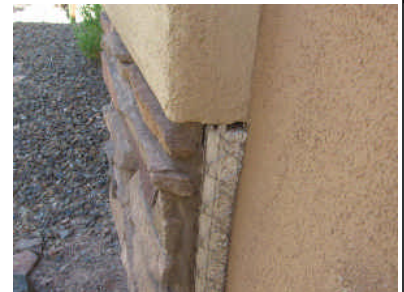
- a. [CR] Missing stucco was noted at the right side of the building. We recommend correcting the condition(s) noted.

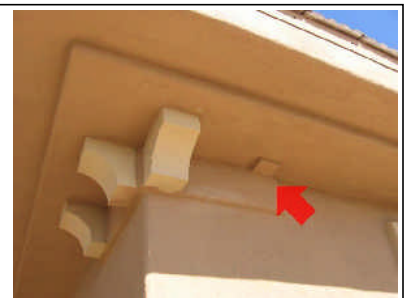
#### 317 EXTERIOR TRIM:

- a. [CR] There was a missing corbel/trim material noted at the right rear of the building. We recommend correcting the condition(s) noted.

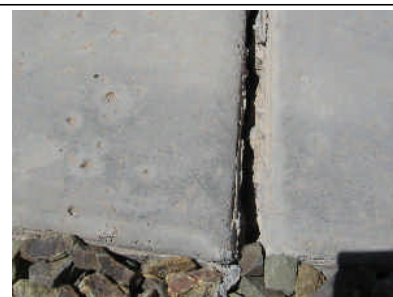
- a. [FE] There were large cracks and heaving or settling of the driveway. We recommend further evaluation and corrections by a specialist in the appropriate trade.

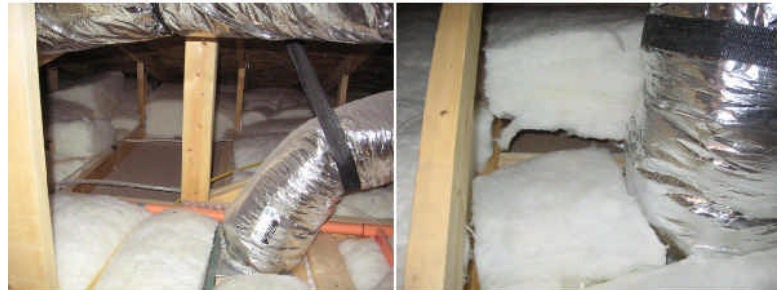
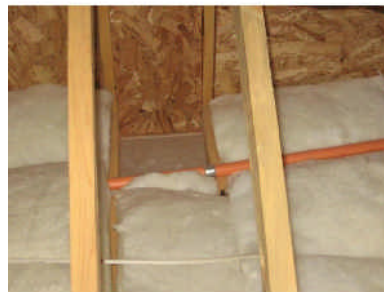
509 INSULATION:

a. [CR] The insulation was out of place or missing in areas. We recommend correcting this condition for energy efficiency.

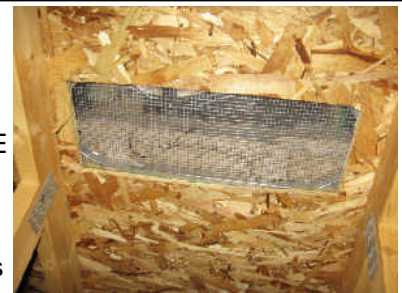
a. [CR] The O'Hagin attic roof vents were not installed per the STANDARD INSTALLATION INSTRUCTIONS FOR O'HAGIN'S CONCRETE TILE VENTS ([www.ohaginvent.com](http://www.ohaginvent.com)) and may allow wind driven rain to enter the attic space, and or the tile(s) were not inserted into the sides of the ohagin vent tile unit, and wind clips were not secured. We recommend correcting the condition(s) noted.

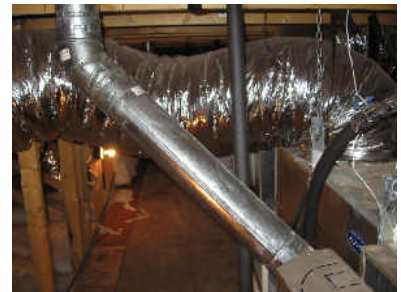
921 CONDITION:

[CR] The conditioned air ducts had minimal supporting straps and restriction of the air flow is likely to occur from sagging ducting. We recommend additional and wider straps be installed to provide adequate support.

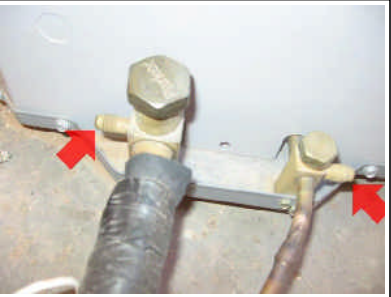
1006 UNIT NUMBER:	[Unit #1]
1007 ENERGY SUPPLY/SAFETY CONTROLS:	An electrical disconnect was present, in sight of and providing power to the condensing unit.
1008 A CONDENSING UNIT:	<p>The condensing unit was serviceable, with exceptions noted.</p> <p>a. [CR] The condensing unit valve caps were missing. This condition may allow freon to leak out. We recommend correcting the condition(s) noted.</p>

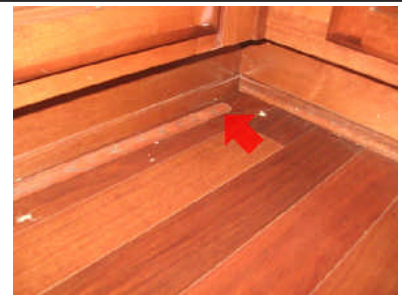
a. [CR] The cabinet trim at the floor was damaged/incomplete. We recommend correcting the condition(s) noted.

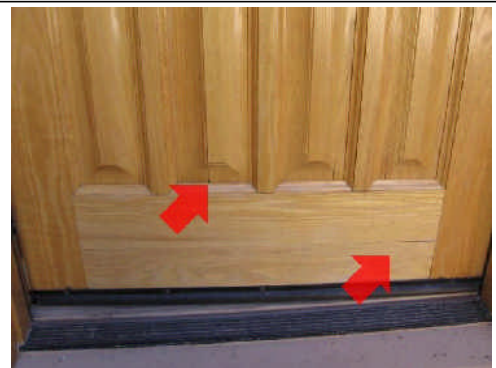
1415 EXTERIOR  
DOORS:

The door(s) were serviceable, with exceptions noted.  
a. [CR] The entry door was damaged/split. We recommend correcting the condition(s) noted.

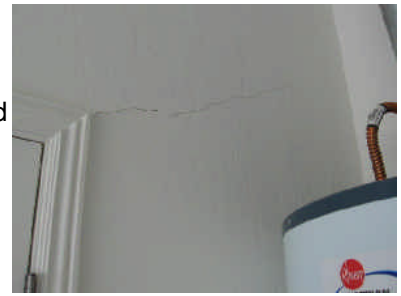
**1548 INTERIOR WALLS:**

The visible areas of the walls and ceiling appeared serviceable, with exceptions noted.  
a. [FE] A large diagonal crack was noted on the wall. We recommend further evaluation and corrections by a specialist in the appropriate trade.
