# Inspection Report

*Property Address:*  
*27100 North 130th Lane, Peoria Arizona 85382*  
*Inspection Date:*  
*November 22, 2006*

**DIAMOND HOME INSPECTIONS LLC**  
Email: [michael@diamondhomeinspections.com](mailto:michael@diamondhomeinspections.com)  
Phone: (602) 499-6995  
Fax: (623) 594-7559

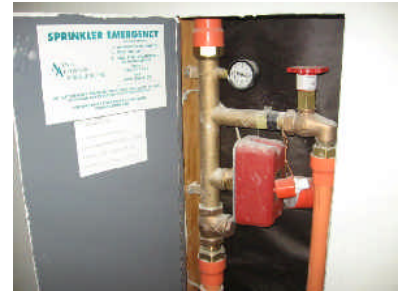
The fire sprinkler controls were located in the garage.

[FE] This system is outside the scope of the inspection and was not inspected. We recommend consulting with a specialist regarding the operation and maintenance of this system.
